Lewiston Fire Department

Fire Station Analysis

Lewiston, Idaho

April 30, 2020

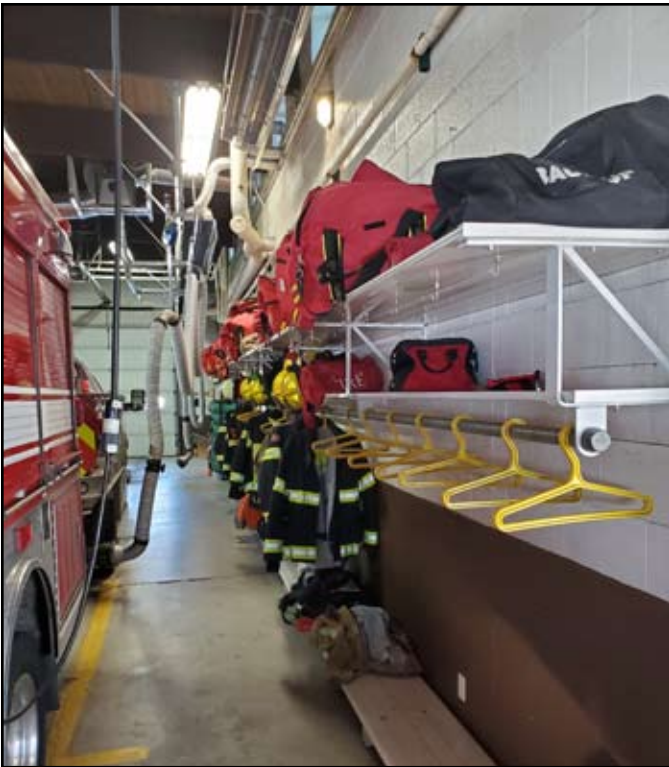
STATION 1: APPARATUS BAY

Turn outs stored in apparatus bay. Extra gear stored in apparatus bay due to lack of storage.

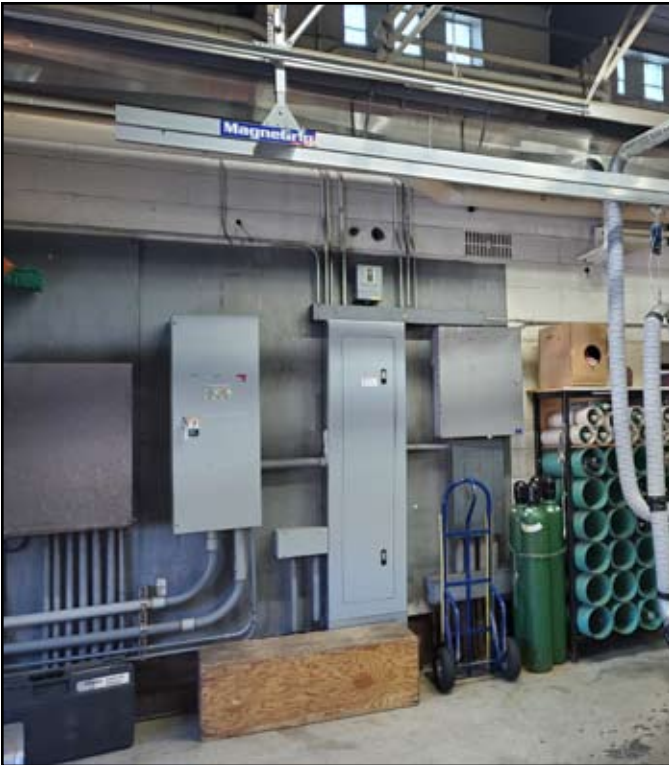
STATION 1: APPARATUS BAY

Electrical and additional air bottles in apparatus bay.

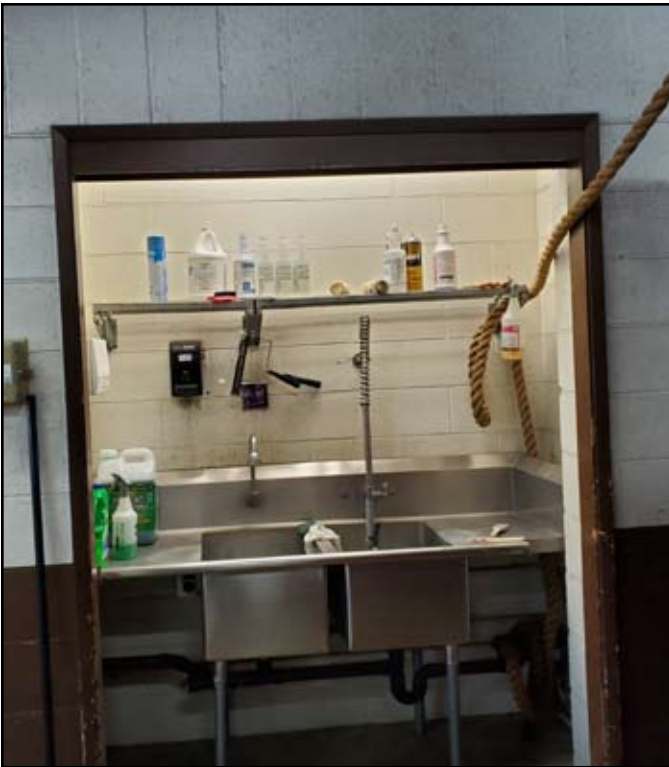
STATION 1: DECON
Alcove in apparatus bay.

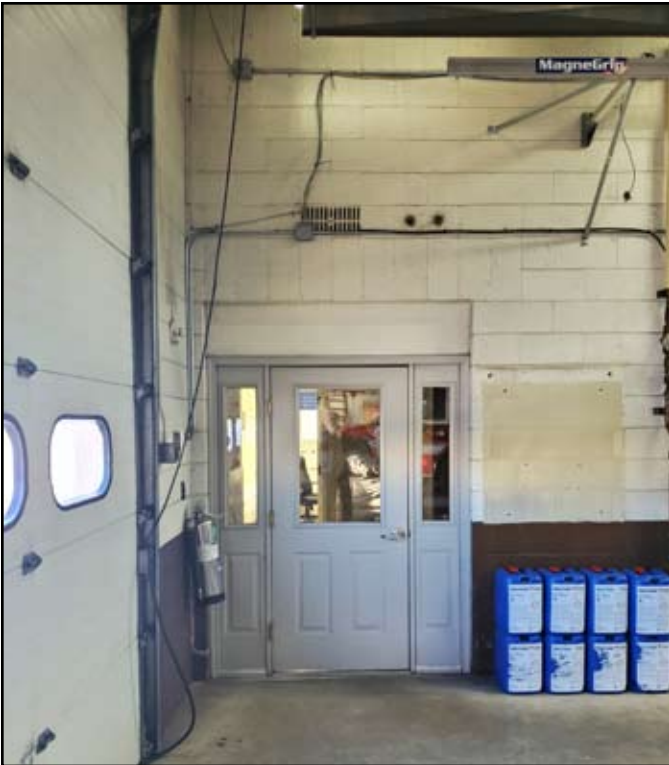
STATION 1: ENT. TO SLEEPING ROOMS
No fire rated separations to sleeping areas.

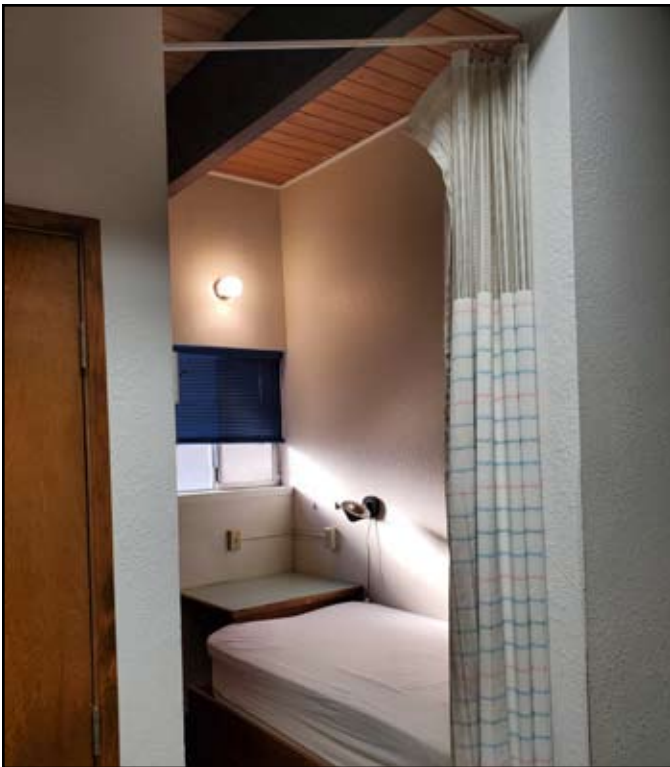
STATION 1: SLEEPING ROOM

Little privacy or seperation. Very small spaces.

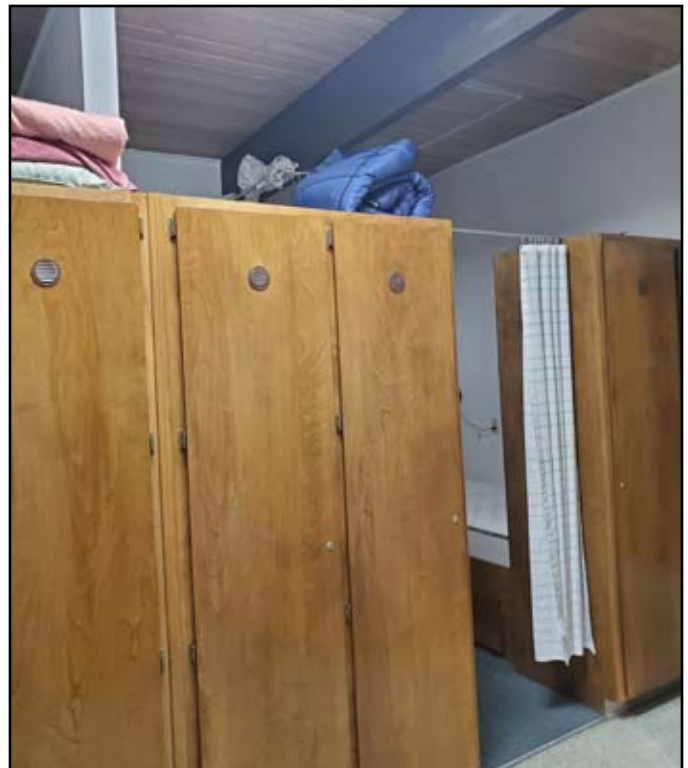
STATION 1: SLEEPING ROOMS

Little privacy or seperation. Very limited storage.

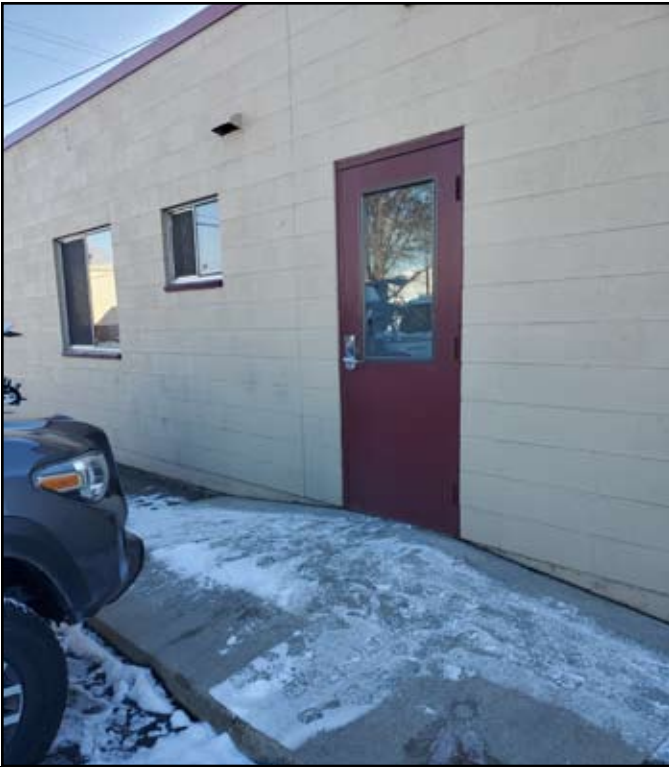
STATION 1: STAFF ENTRANCE
Dangerous slopes, doors don't meet ADA.

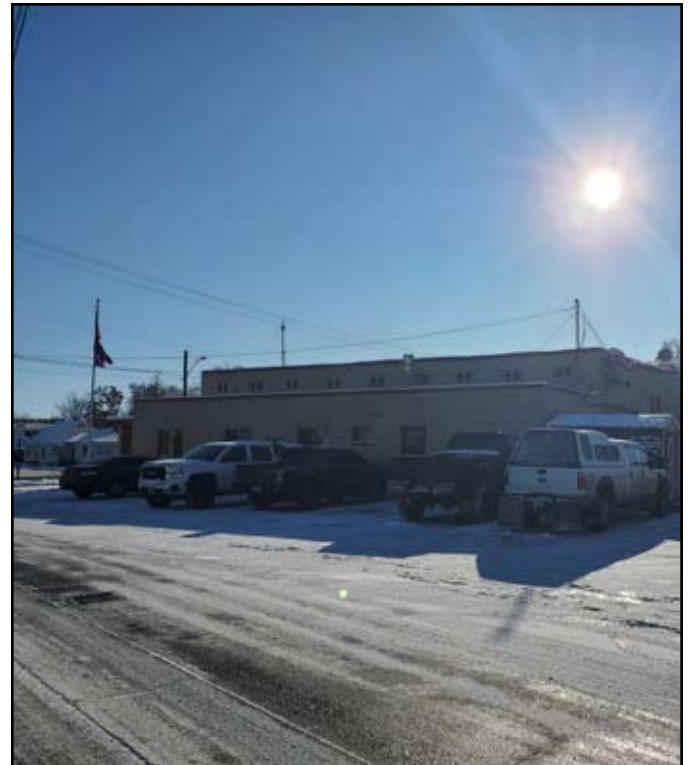
STATION 1: NORTH SIDE
Staff parking.

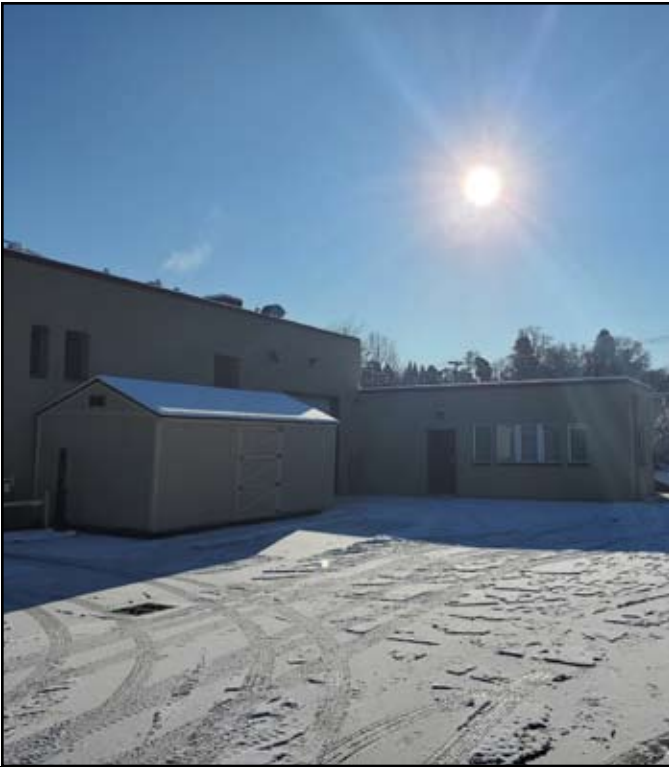
STATION 1: WEST SIDE DAY ROOM ADD.
Small storage building due to lack of storage in building.

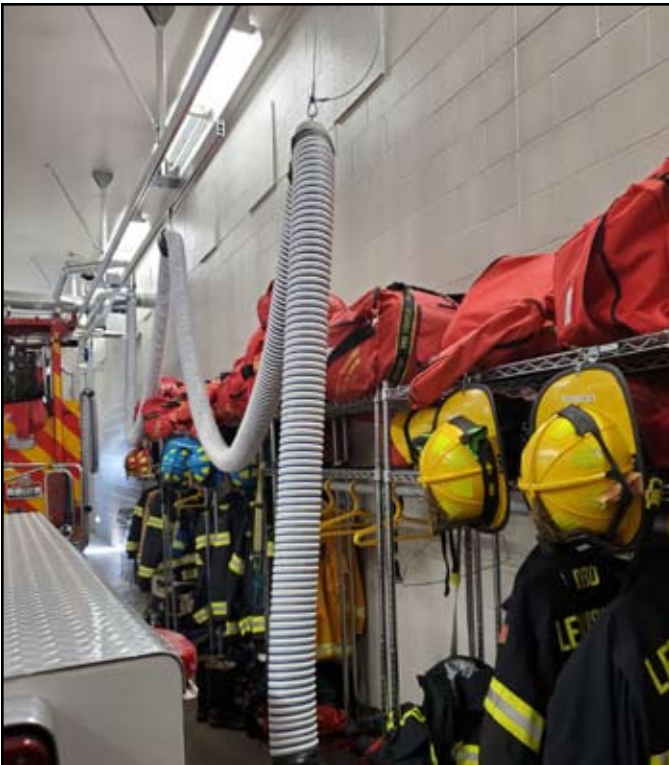
STATION 2: APPARATUS BAY
Turn out gear in apparatus bay.

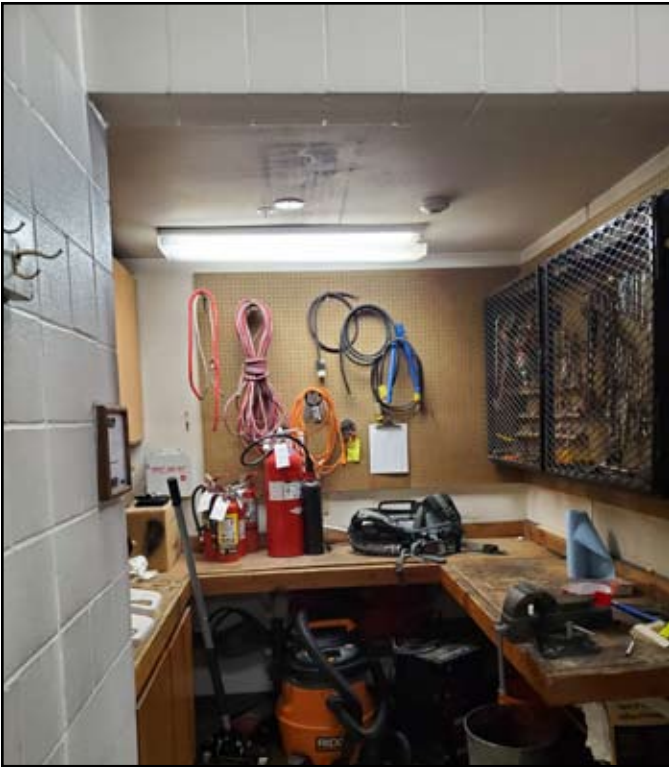
STATION 2: WORK ALCOVE OFF APPARATUS
Small, undersized work area.

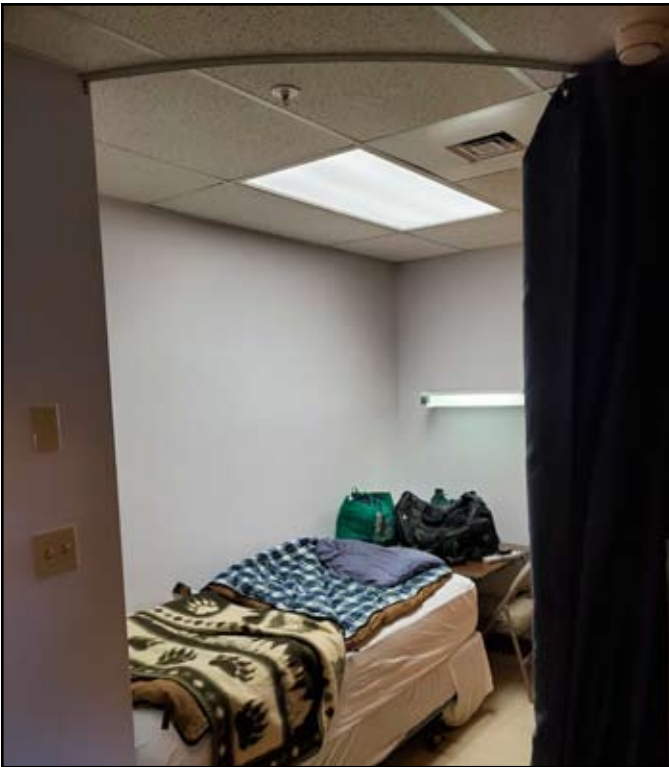
STATION 2: SLEEPING AREA

Sleeping areas small, lack of privacy, & storage.

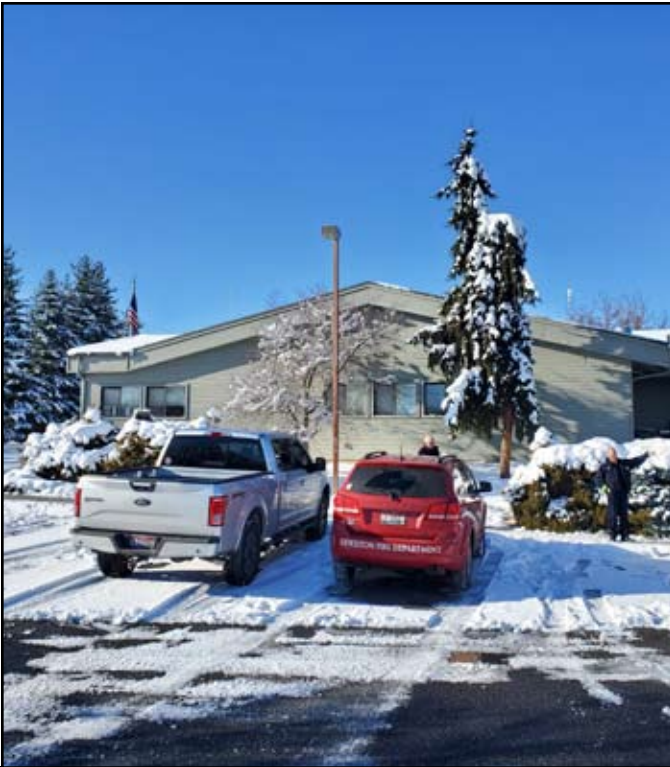
STATION 2: EAST SIDE PARKING
Limited staff parking.

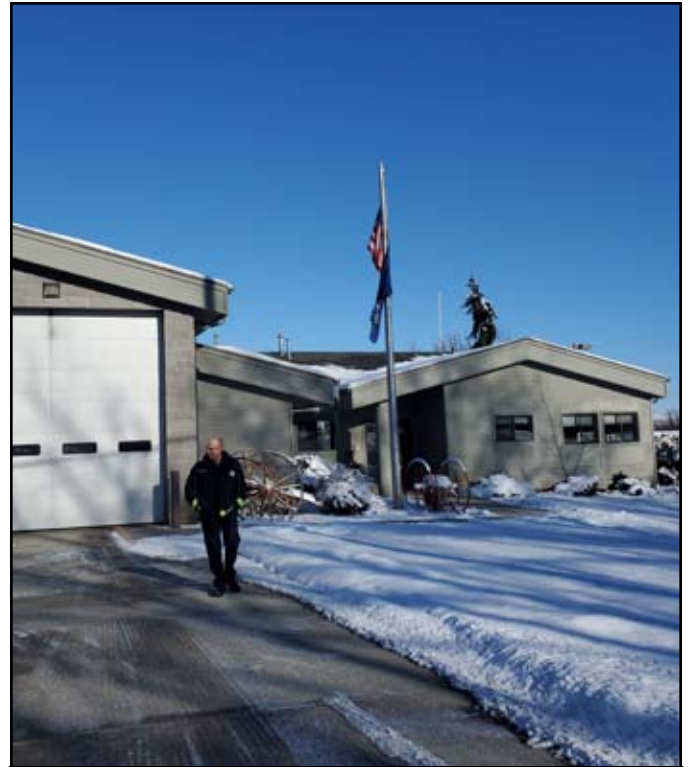
STATION 2: SOUTH SIDE ENTRANCE
Public Entrance.

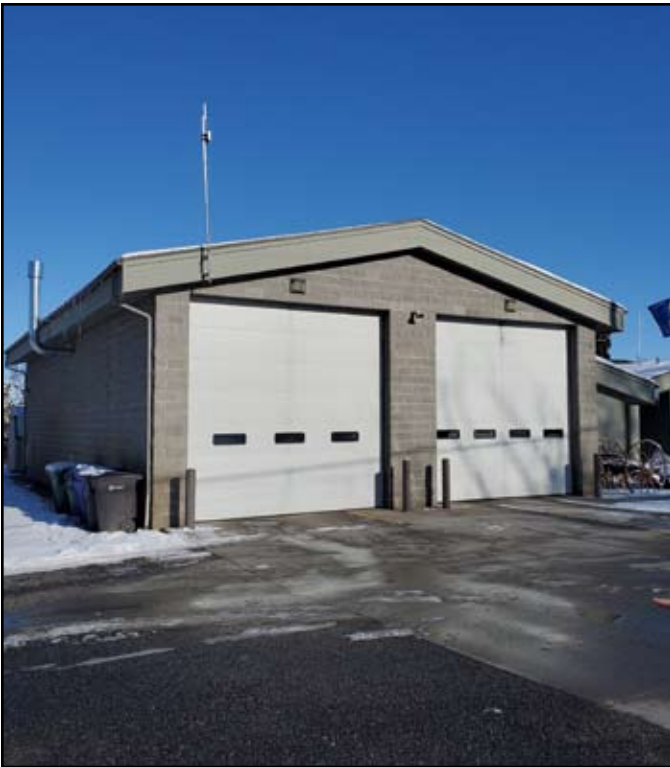
STATION 2: SOUTH SIDE
Large Apron. Lots of room for expansion.

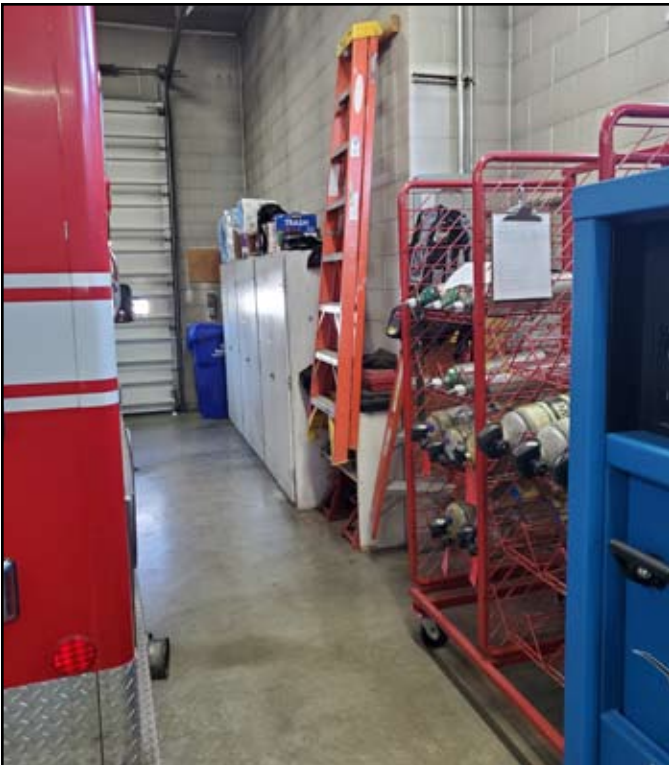
STATION 4: APPARATUS BAY

Additional air storage in apparatus bay.
Should be in a separate room.

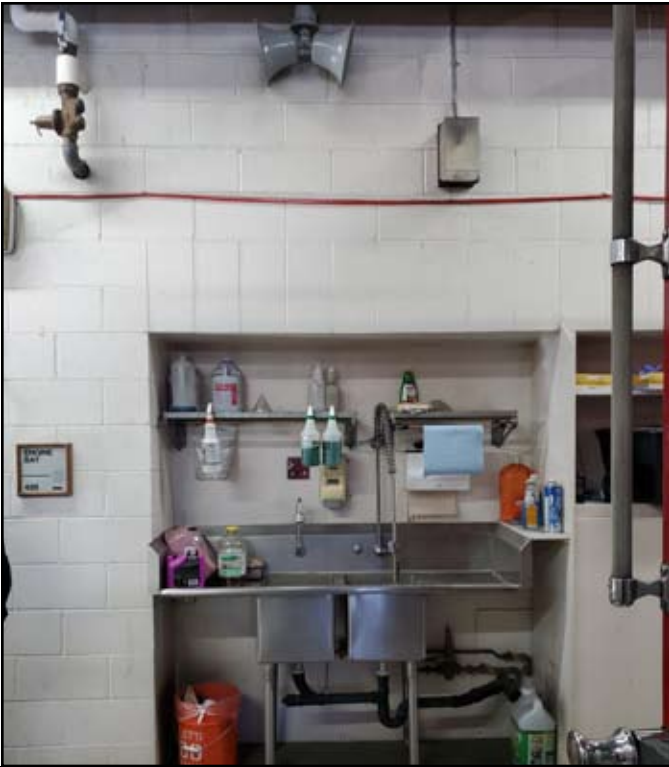
STATION 4: DECON

Decontamination/cleaning - the limited facilities observed are not enclosed and segregated from the bays.

Undersized and in apparatus bay.

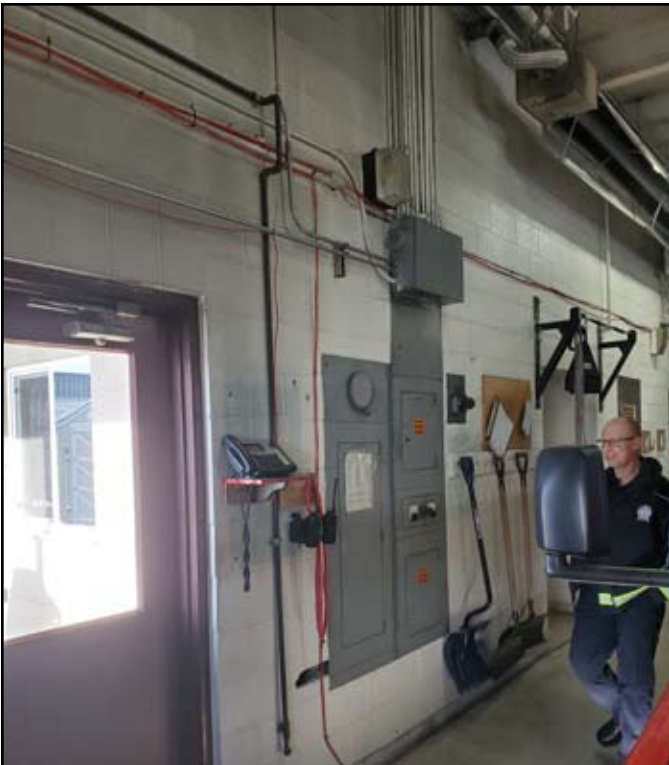
STATION 4: ELECTRICAL

The size of the service appears adequate for the buildings electrical needs a significant renovation will most likely demand a service replacement. The Electrical service is very old and appears to be original to the building. Parts may be difficult to obtain due to the age.

Very old, located in apparatus bay.

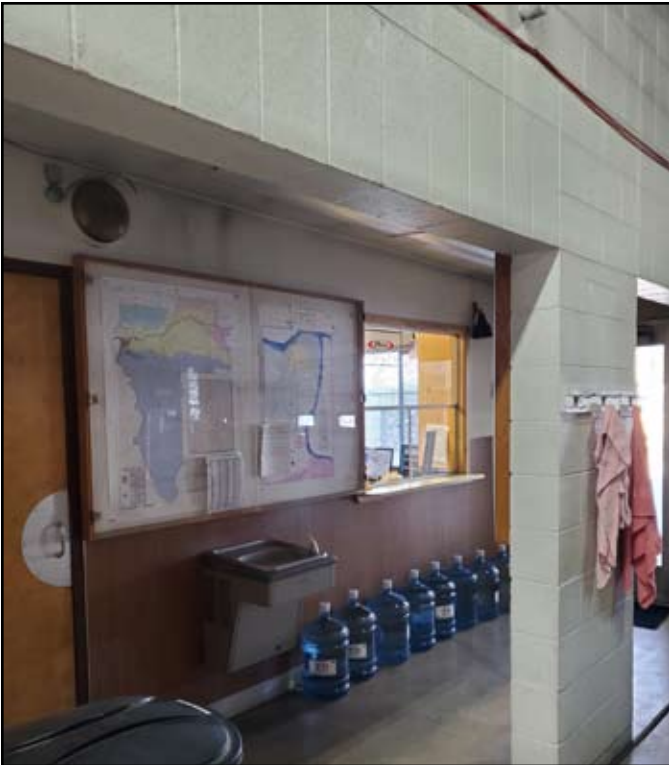
STATION 4: ENTRY WAY
Part of apparatus bay, not separated.

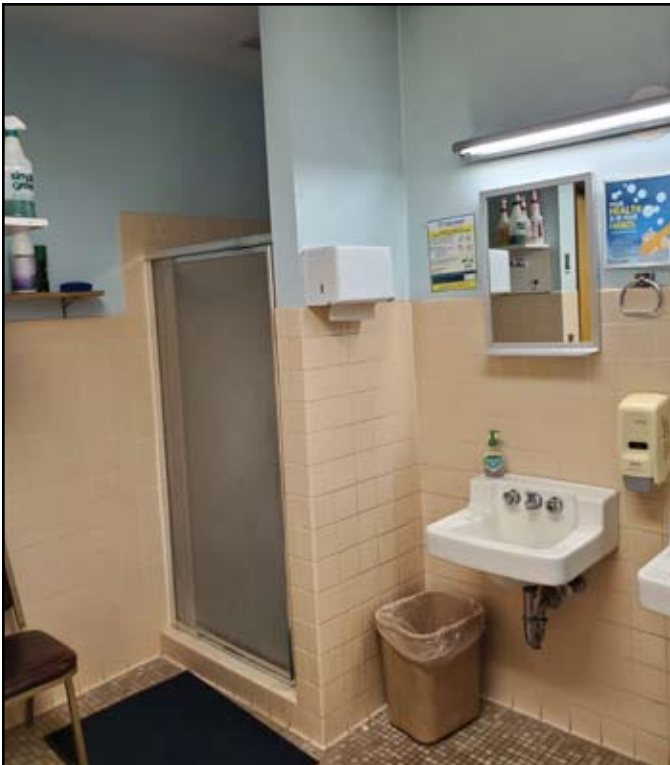
STATION 4: RESTROOM & SHOWER
Only one shower. Not ADA accessible.

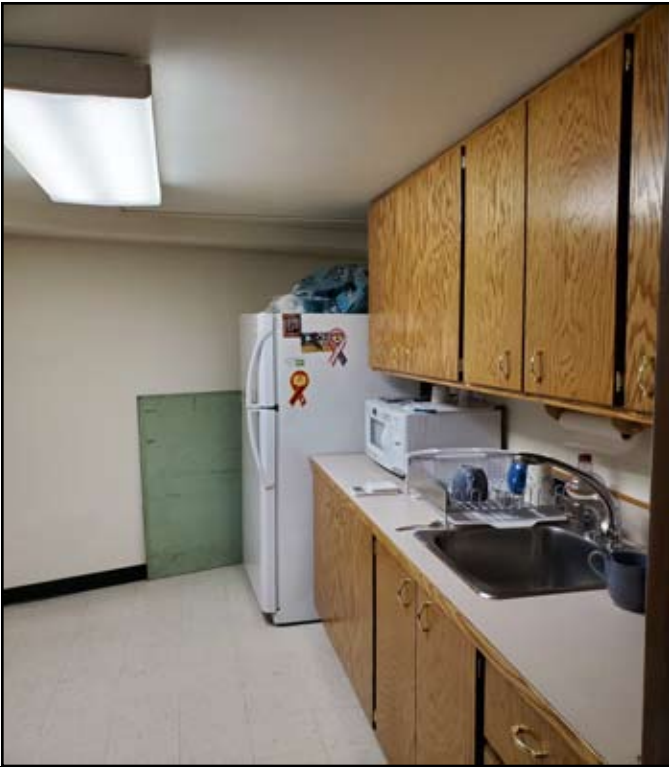
ADMIN: BASEMENT BREAKROOM

Not ADA accessible to all staff because it is located in the basement.

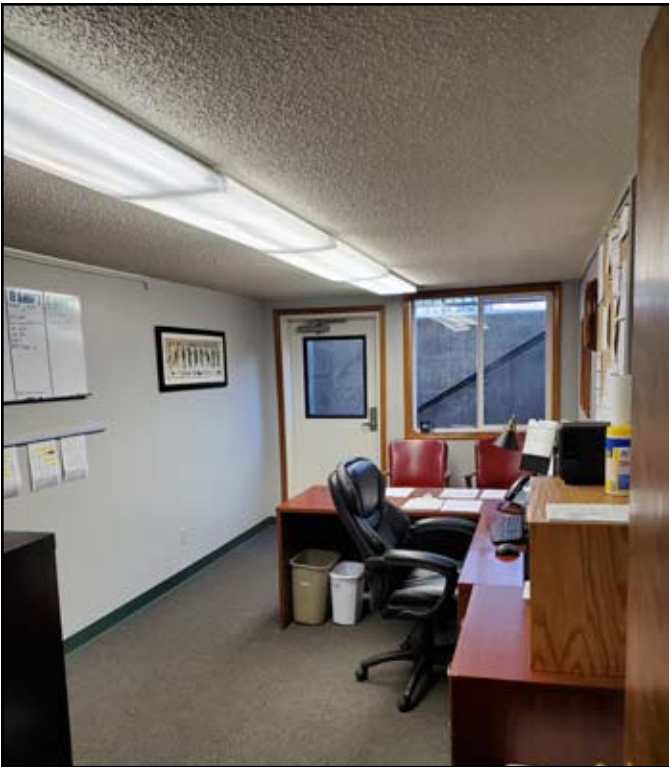
ADMIN: BASEMENT OFFICE

Office occupies egress path to second exit.

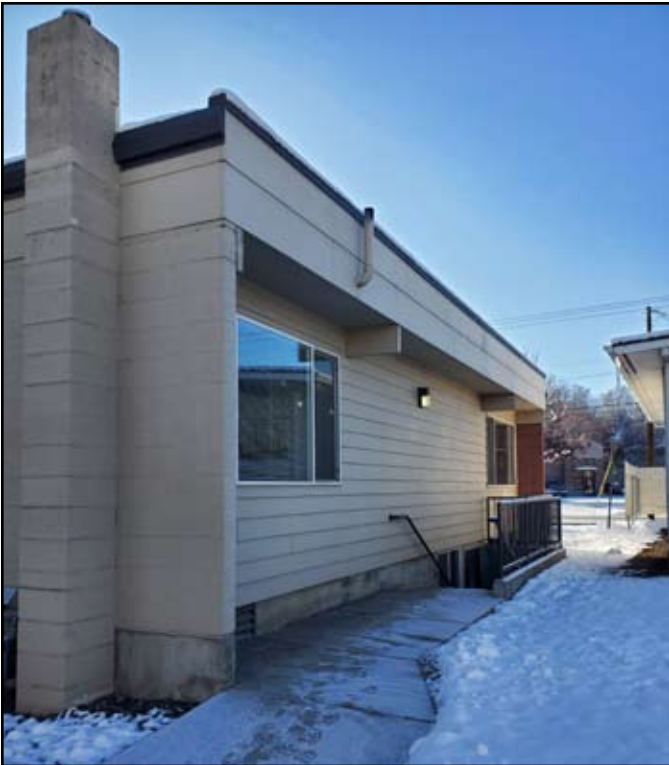
ADMIN: WEST ELEVATION
Second basement egress.
